Home Inspection Report

1212 Nowhere Street, Yourtown, USA 00000

Pasqua Building Inspections, Inc
6341 Raleigh Street, Hollywood, FL, 33024
www.pasquainspections.com
(954) 981-2365

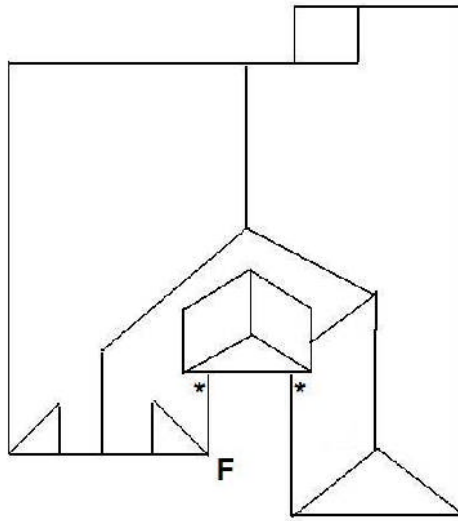
ROOF DIAGRAM

The wood fascia is deteriorated in area(s) as indicated with "F" on the roof diagram.(refer to Wood Destroying Organisms Report)Repair or replace the affected areas.

The roof is leaking in area(s) as indicated with "*" on the roof diagram. Recommend repairs by a licensed roofing contractor.

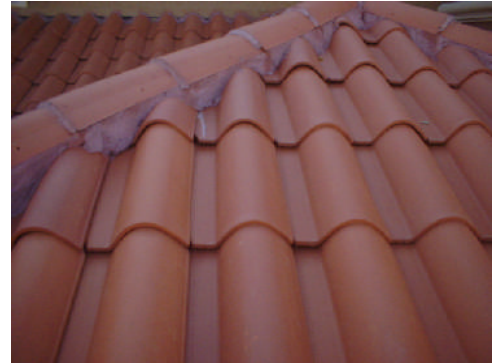
Photo # 1 VIEW OF ROOF SURFACE

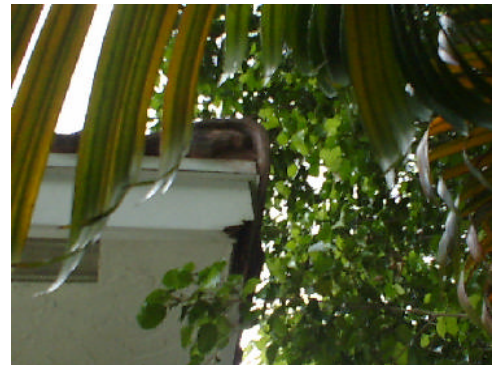
Photo # 2 DETERIORATED FASCIA

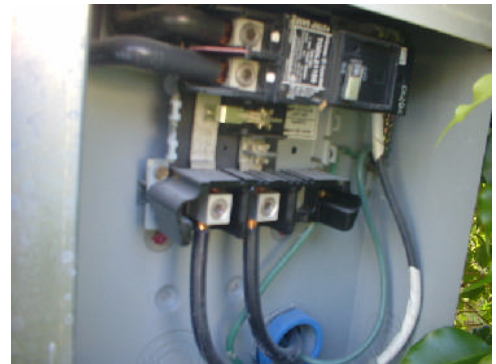
1. There were double tapped breakers present in the main panel. Have the circuits separated by a licensed electrician, and allow for corrections as needed.
2. A globe for an exterior light was broken or missing at the exterior. Allow for repairs or replacements as needed.
3. The master bedroom ceiling fan is not grounded. Ground the fan for safety reasons.

Photo # 3 VIEW OF MAIN PANEL

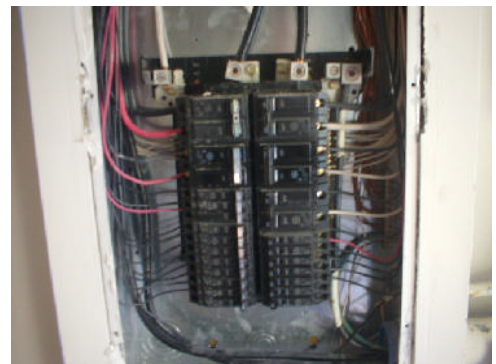
Photo # 4 VIEW OF SUB PANEL

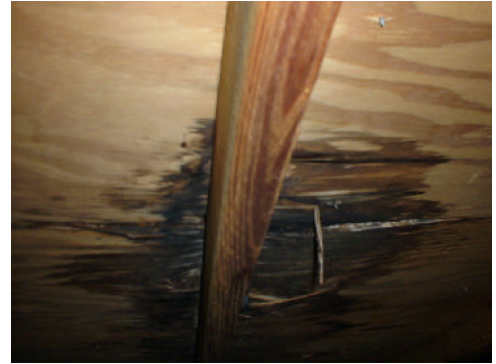
Photo # 5 ROOF LEAK AS OBSERVED FROM ATTIC

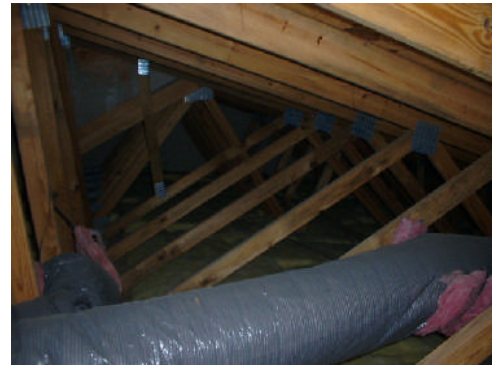
Photo # 6 ATTIC WAS ENTERED
